# Structural behavior of Pracana dam 30 years after rehabilitation due to severe ISR-ASR damage

José Piteira Gomes  
Domingos Silva Matos  
António Lopes Batista  
José Ilídio Ferreira

GOMES, J. [et al.] – Structural behavior of Pracana dam 30 years after rehabilitation due to severe ISR-ASR damage. **Revista Portuguesa de Engenharia de Estruturas**. Ed. LNEC. Série III. n.º 16. ISSN 2183-8488. (março 2021) 85-94.

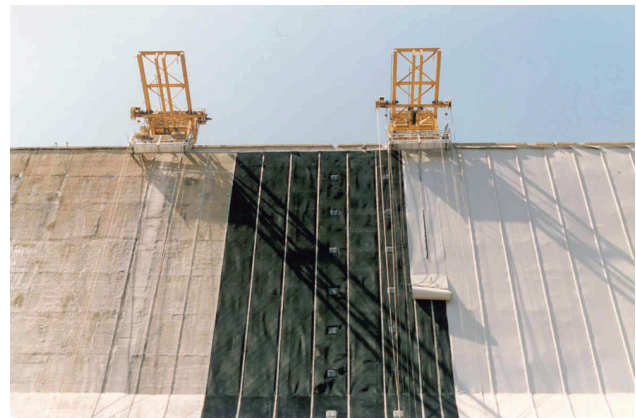
Figure 2 Stage of installation of the upstream impervious membrane

The waterproofing system of the upstream surface consists of a non-adherent synthetic membrane in order to prevent the contact of the reservoir water with the concrete and, thus, stop the water supply to the ASR and simultaneously prevent the uplift developing in existent cracks of the buttresses heads (Figure 2). The system selected by EDP is a Carpi patented system consisting of an impervious flexible PVC geomembrane 2.5 mm thick, heat-coupled during extrusion to a non-woven, needle-punched 500 g/m<sup>2</sup> geotextile. The PVC geomembrane, which was applied over a HDPE geonet with drainage purpose, fulfil many requirements, namely: i) low permeability ( $k \approx 10^{-12}$  cm/s); ii) high flexibility, that enables installation also on not smooth faces; iii) resistance to punching, tearing and impact; iv) resistance to high temperature gradients and to freeze-thaw cycles; v) resistance to stresses induced by large relative movements,

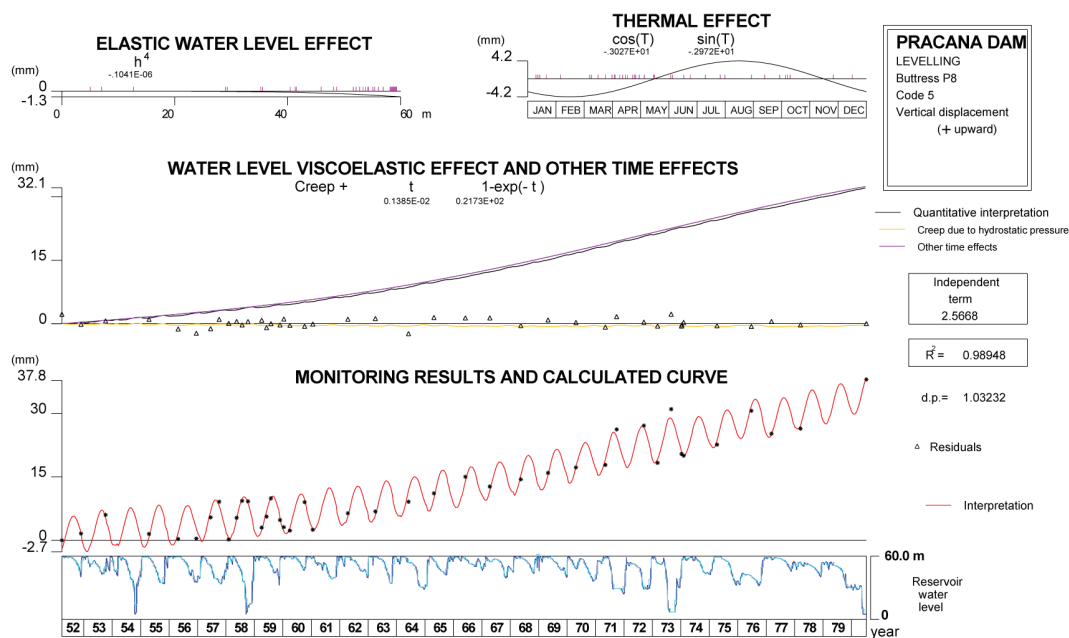
the detection of irreversible upward displacements and, also, downstream horizontal displacements, on the blocks B0 and B14 and on buttresses P2, P4, P6, P8, P10, P11 and P12. Just before the decision of stopping the operation and emptying the reservoir was taken, the quantitative interpretation results showed that the crest irreversible components of vertical and horizontal displacements, related to the time effect, were, very high, with average rates of 1.0 mm/year and 1.2 mm/year, respectively. Figure 6 shows the results of the statistical model application for vertical displacements measured on P8 buttress, since 1952 to 1980. A value of about 32 mm was computed to the irreversible vertical displacement due to the swelling process.

**Figure 6** Results of statistical model application for vertical displacements measured on the top of P8 buttress since 1952 to 1980

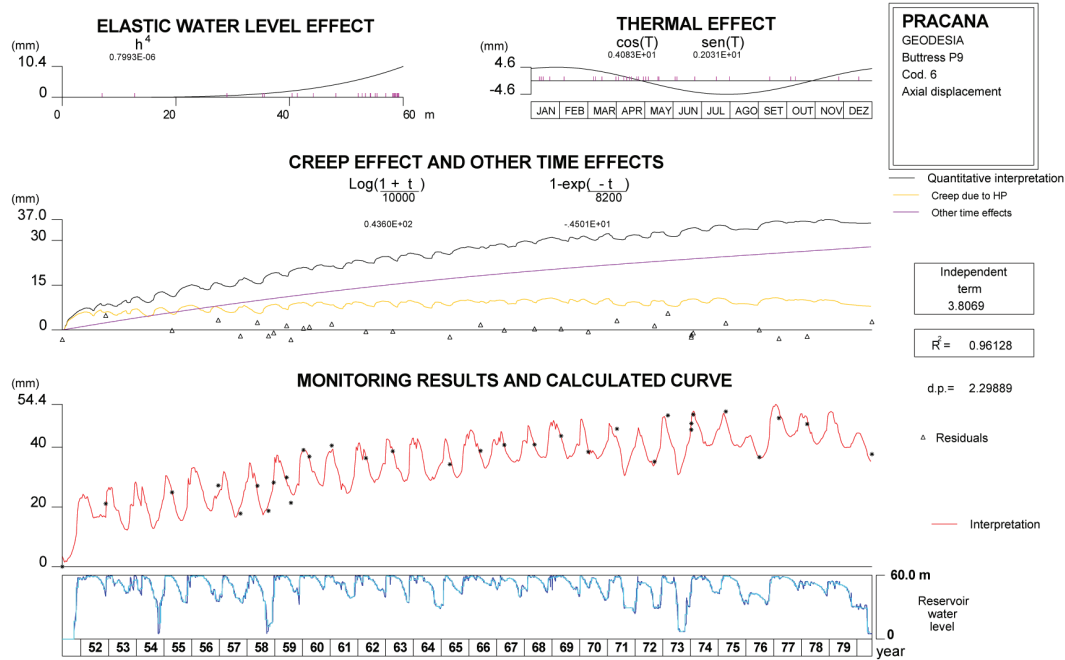
**Figure 7** Results of statistical model application for horizontal (U-D) displacements measured on the top of P9 buttress since 1952 to 1980

In Figure 7 the results of statistical model application for horizontal upstream-downstream (U-D) displacements measured on the top of P9 buttress, since 1952 to 1980, are presented. Large irreversible displacements were computed in the downstream direction due to creep and swelling.

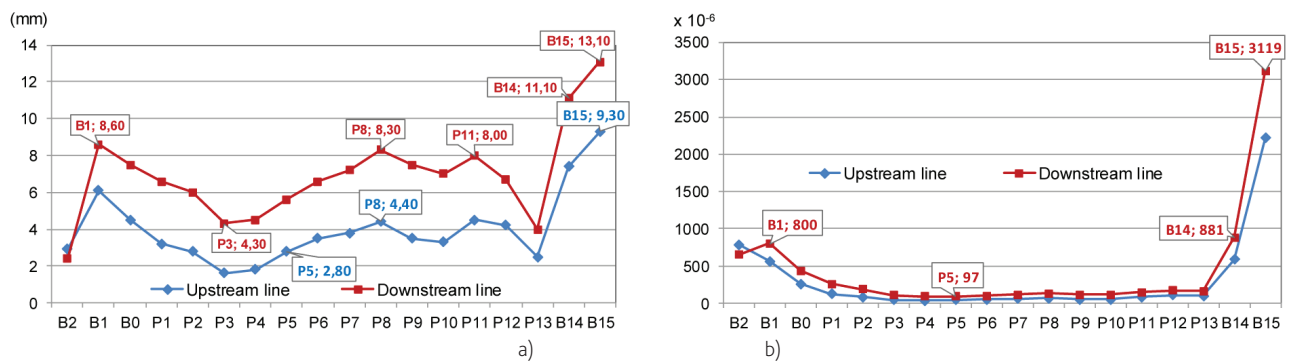
that in the side blocks B1 and B0 on the right bank and B14 and B15 on the left bank the displacements are very significant. The corresponding calculated irreversible displacements correspond to vertical strain, accumulated during 27 years, that are small in the central zone of the dam, with average values below  $100 \times 10^{-6}$  and

high deformations in the side blocks, mainly on the two blocks close to the left bank, as can be seen in Figure 9.

**Figure 9** a) Irreversible vertical displacements on levelling marks at crest and b) accumulated vertical strains on the buttresses and side blocks

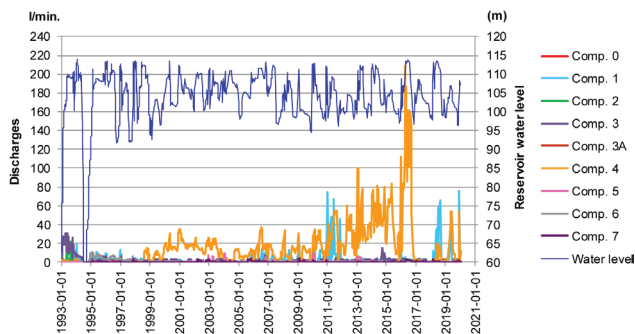
Figure 11 shows the discharges evolution in the different geomembrane drainage compartments. As can be seen, in the compartments 1 and 4, where several membrane ruptures have occurred, the discharges were higher. In compartment 1, where the most significant ruptures occurred in 2011, 2018 and very recently (December 2019), the discharges have reached maximum values of about 75 l/min. The discharges from compartment 4 had a first increase between 2000 and 2003, with maximum values of about 65 l/min, but since 2011 to 2016 the increase was higher, reaching a maximum value of 209 l/min in April 2016. In November 2016 there was a geomembrane repair intervention that drastically

reduced those discharges. However, in 2019 new rips appear to have occurred.

**Figure 11** Discharges evolution in the different geomembrane compartments

It should be noted that the measured values of the water level in the compartments have been systematically zero, which indicates there is no accumulated water between the geomembrane and the upstream surface of the dam, and that the compartment drains have an appropriate discharge capacity. Nevertheless, preventive actions must be taken to remove the solid material that floats in the reservoir, particularly in flooding periods, to avoid its impact on the geomembrane, which has been the cause of the rips that have occurred.
