# Reinforcement and replacement interventions in some bridges located on Aguieira dam road network

Tiago Rodrigues  
Ana Rita Pereira  
André Martinez Costa

RODRIGUES, T. [et al.] – Reinforcement and replacement interventions in some bridges located on Aguieira dam road network. **Revista Portuguesa de Engenharia de Estruturas**. Ed. LNEC. Série III. n.º 15. ISSN 2183-8488. (março 2020) 95-106.

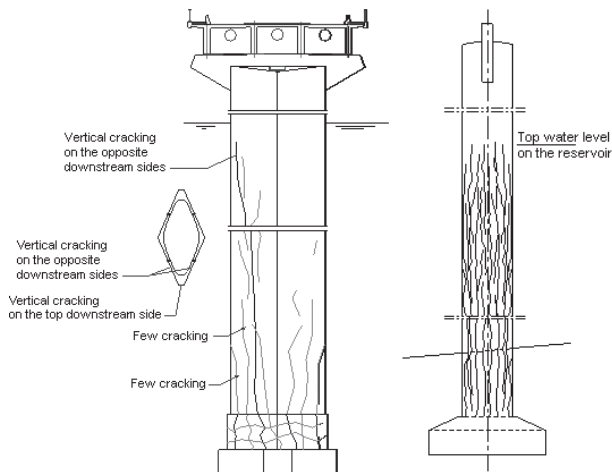
- Several cracks in piers foundation, particularly at the basement level, with random orientation, typical of swelling reactions;
- Vertical cracking, mainly in the pier/basement connection, over all the piers perimeter, with uniform spacing;
- Vertical cracking in the piers shaft, with some spot zones with steel corrosion and deficient concrete joints.

Figure 12 Cracking observed on Foz Dão Bridge piers [1]

The results of the studies developed by LNEC on these bridges have concluded the presence of internal swelling reactions, namely alkali-silica reaction (ASR) and internal sulphate reaction (DEF). These reactions were manifested through the cracking and deterioration of the superficial layer of the concrete, with more expression in the structural elements in contact with permanent water or water-flow.

The cracking that occurred in some sections of the pier shafts immersed on the reservoir, was predominantly oriented along the vertical direction. This situation was related to the confinement effect in this direction provided by the axial compression to which they are subjected. The development of cracking was in all submerged pier height, sometimes increasing their expression in depth.

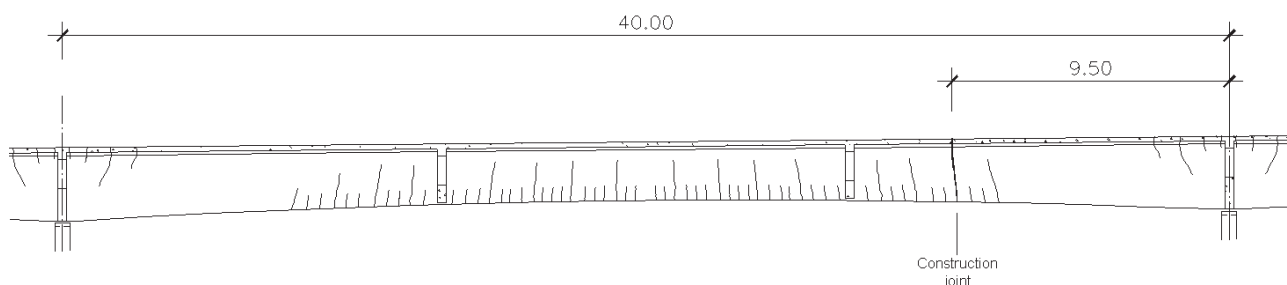
- Excessive deflection of the deck, easily observable, with values greater than 5 cm;
- Areas with concrete poorly vibrated or with poor connection between different age concrete at construction joints, with honeycombs;
- Vertical cracks on the longitudinal girders, associated with bending, resulting from the reduced compression introduced by the applied prestress;
- Some transversal cracks on the deck slabs, next to the transversal girders located above the piers;
- Concrete degradation, such as delamination and rebar corrosion, associated to carbonatation effects;
- Crushed or damaged lead bearings;
- Cracks on the transversal girders located above the piers, next to the external longitudinal girders;
- Cracks on the abutments, due to the swelling reactions, and structural defects.

Figure 13 Cracks distribution on the girders [1]

Considering the poor performance of the existing prestress, the deck was reinforced through external prestressing in the four longitudinal girders of the deck. This measure improved the service behaviour of these elements, resulting in an important increase in their performance.

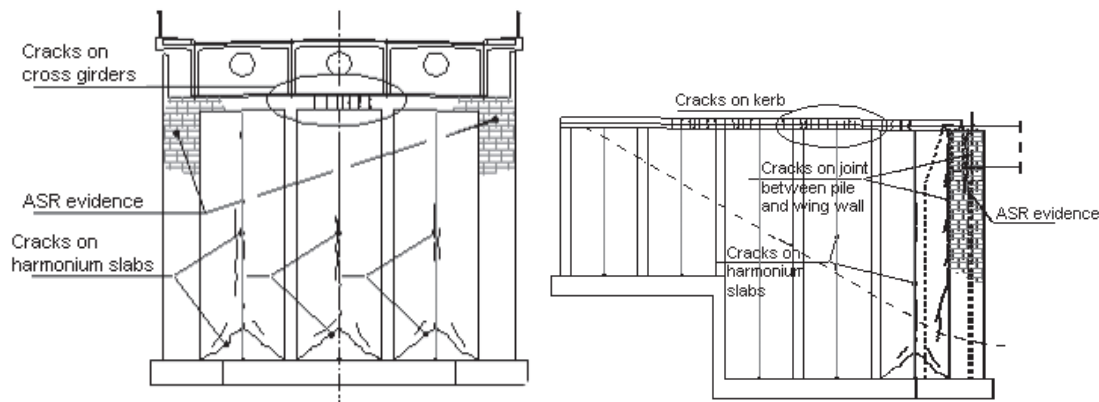
Figure 14 Anomalies detected on the front walls and wing walls of abutments [1]

- Abutments reinforcement, through the placing of a slab on the wing walls and counterforts of the existing wing walls and on an alignment of piles built along the road axis;
- Removal of the abutments interior fill until the ground level, in order to reduce the soil pressure;
- Reinforcement of the abutment bearing beams, piers and abutments transversal girders, through jacketing with new elements of reinforced concrete and prestressing application;
- Piers cap beam reinforcement through the adoption of prestressing and jacketing, in order to allow the load transfer from the bearings to the piers;
- Concrete rehabilitation and cracks injection, including coating;
- Expansion joints replacement;
- Structural bearings replacement;
- Drainage systems repair and relocation.

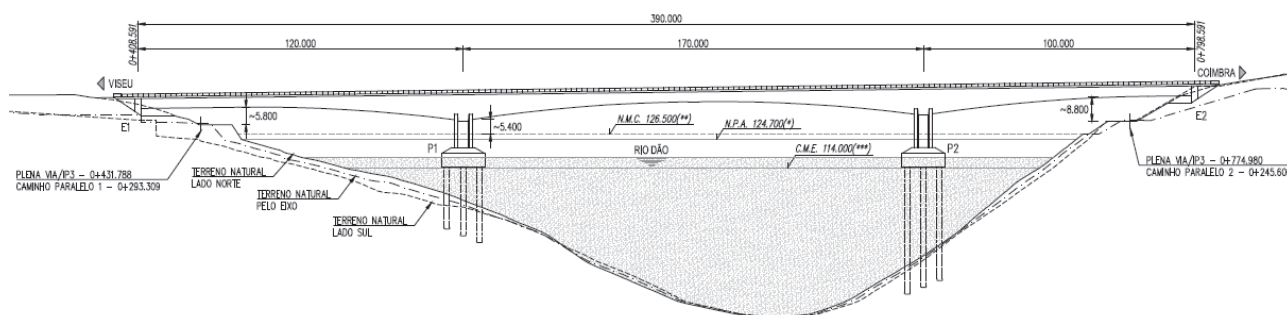
Currently, 3 of the 8 piers that support the deck structure have a permanently submerged height of more than 50 m (the P5 pier is 60 m height), making it very difficult to work at these depths. It is important to underline that the elements with more evident deteriorations, caused by the swelling reactions, are the pier basements, the elements at the bottom of the piers where the shaft becomes larger. Therefore, it wasn't possible to make any reinforcement solution along the piers height (like the ones of Cunheda, Mortágua and Santa Comba Dão Bridges), once it wasn't possible to use technical and human means to execute correctly these kind of works at the mentioned depths. Another solution would be to execute the reinforcement by jacketing in half of each pier height, supported by a reinforced concrete pile cap located at the medium height of the reservoir, which in turn would be supported by a set of piles, executed with a tube, that would work like piers. This solution was also implemented on the Criz I, Criz II and São João de Areias bridge piers, and showed to be adequate where the reinforcement by jacketing along all the pier height is costly and complex because of the piers submerge height. However, given some of Foz do Rio Dão bridge foundations were very deep, it wasn't possible to guarantee the piles verticality, which makes this solution extremely complex and extremely difficult to perform.

**Figure 19** New Foz do Dão Bridge [8]

Thus, the studied solutions included the piers replacement or the full bridge replacement. At the end, the full bridge replacement was proved to be the better solution.
