Structural analysis of the Barrô Romanesque Church

OLIVEIRA, D. [et al.] – Structural analysis of the Barrô Romanesque Church. **Revista Portuguesa de Engenharia de Estruturas**. Ed. LNEC. Série III. n.º 17. ISSN 2183-8488. (novembro 2021) 61-70.

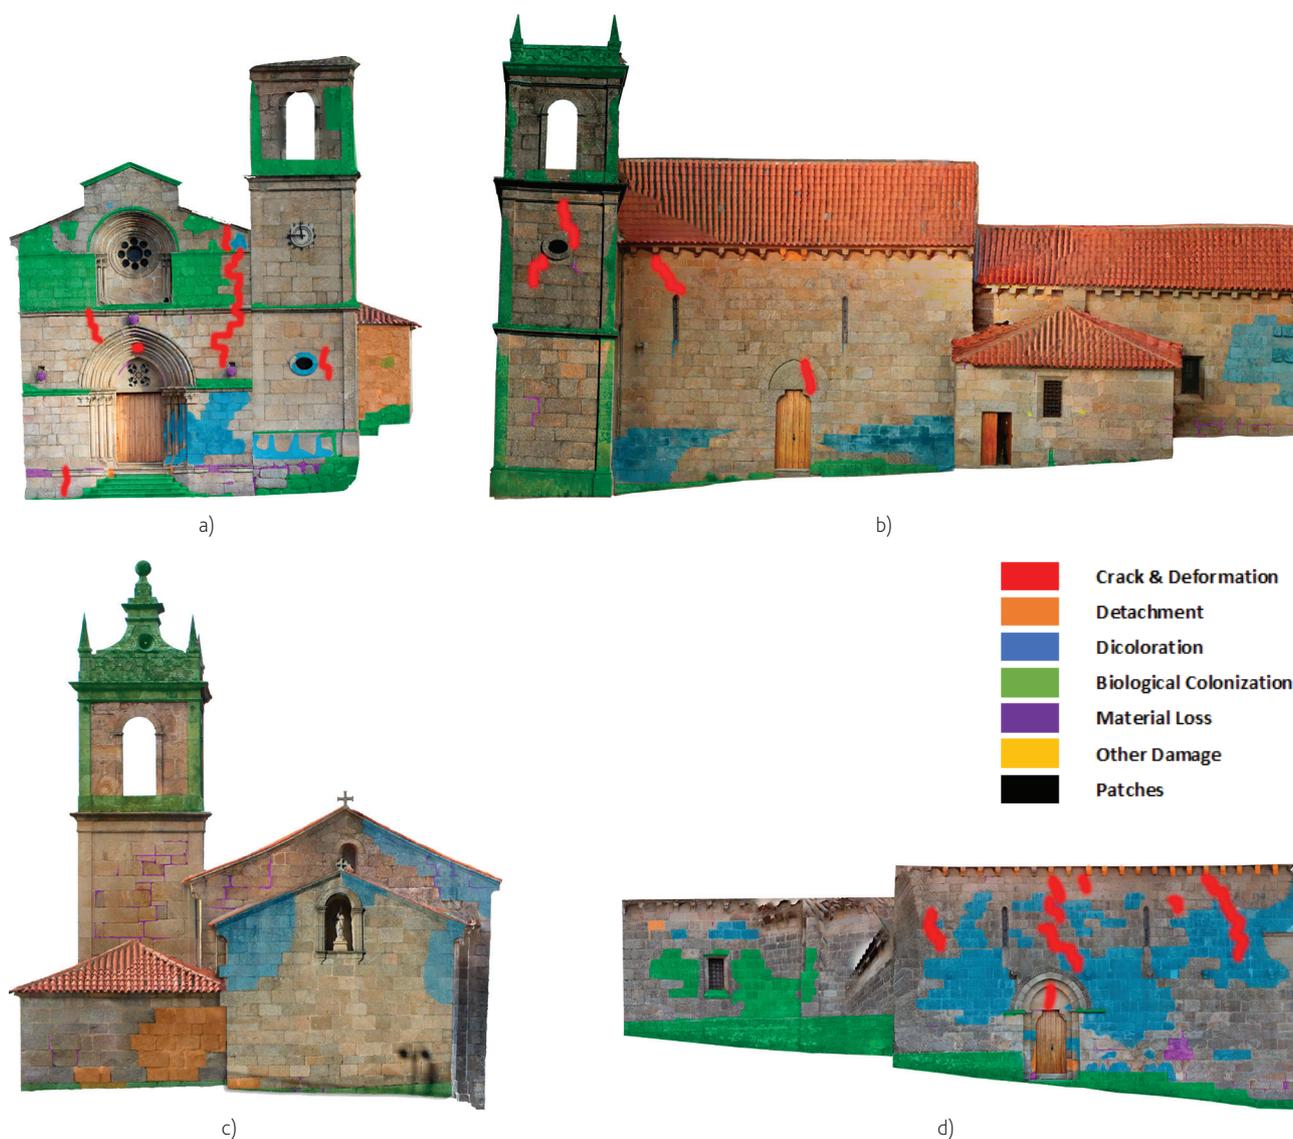
Figure 3 Damage maps: a) west facade; b) south façade; c) east façade; d) north façade

The exterior of the Church showed disintegration of the granite

stone with signs of detachment of single grains or aggregates of grains. Scaling detachment was observed in localized parts. This is an effect of decay that can be related to the erosion of stones due to salt crystallization. The exterior of the Church shows other damages due to erosion, including loss of matrix and rounding of the edges close to the joints. There are also missing parts of the façade elements. The façades of Barrô Church have several cracks that can be classified as fractures. Especially in the West façade, significant cracks were observed in the wall above the choir. The West façade also shows a black crust. Around the Church, several types of biological colonization were observed, including plants, algae, and lichens. Biofilm was also observed, especially in the North Façade. Figure 3 shows the damage maps drawn on top of the Photoscan model mapped according to [2].

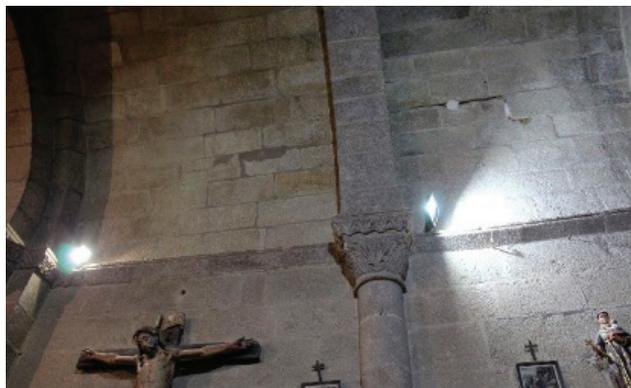
The interior of the Church shows signs of cracking. The most significant crack is visible in the vault of the main chapel. The North façade wall of the Church has signs of deformation, which was observed clearly from the interior of the Church since the wall and one of the columns of the Main Chapel are exhibiting concave deformation. The interior of the Church shows signs of patina and staining due to moisture. Figure 4 shows the damages described, respectively from left to right.

Figure 4 Interior damage: a) crack in the vault; b) deformation of the column; c) patina

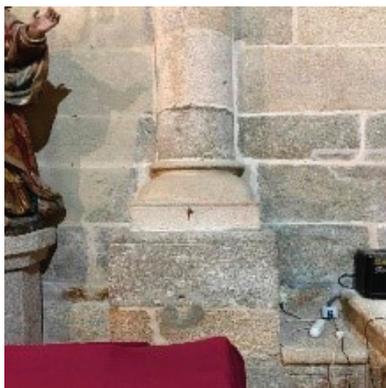
b)

As discussed earlier, the structure is located on sloping ground, with rocky strata. From the site inspection, stepped continuous footings along the wall were observed. Also, from the visual inspection, it was observed that the north wall of the main chapel is bulging outside with a degree varying from 4 to 1 from east to west direction. The cause of this observation was traced to the actions done by either a seismic activity or due to differential settlements of the structure. For that reason, two different types of support systems were applied to observe the behavior of that wall in the linear elastic analysis. The first support system was composed of hinge supports applied to the foundation level surfaces and in the other model, the support consisted of subgrade elasticity at the foundation level. The observations made from the linear elastic analysis of both modeled to the same results for the bulging of the northern wall. As no difference between the results was found, it was decided to use hinge support for surfaces for the nonlinear analysis.

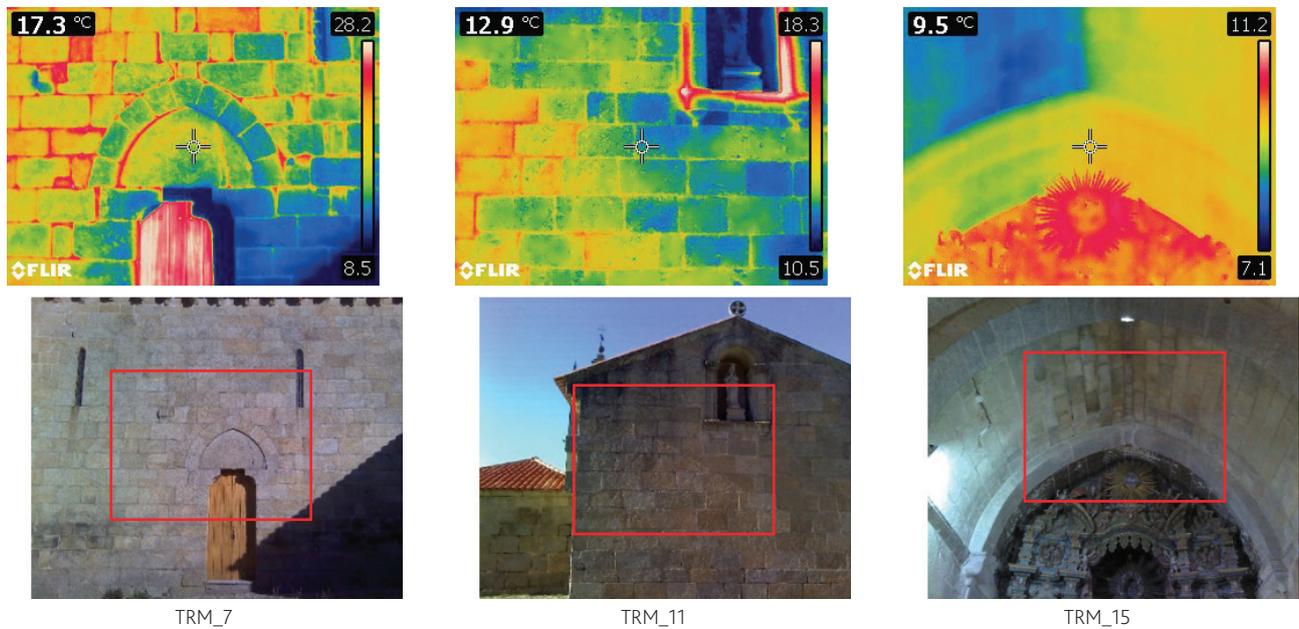
Figure 6 Thermal camera pictures (top) and the part they represent (bottom)

From TRM_7, it can be observed that on the left side there is a clear separation of the arch above the door to the stone filling underneath, not clearly visible to the naked eye. Additionally, from TRM_11 another distinct separation between the sculpture stand and the rest of the wall can be seen. TRM_15 shows material differences between the altar and the stone vault, which has a clear

thermal separation line at the apex. This separation comes from the orientation of the church where the left side (of this picture) is the northern side whereas the right side is the southern side, which at the time of measurement was constantly in contact with the sun.

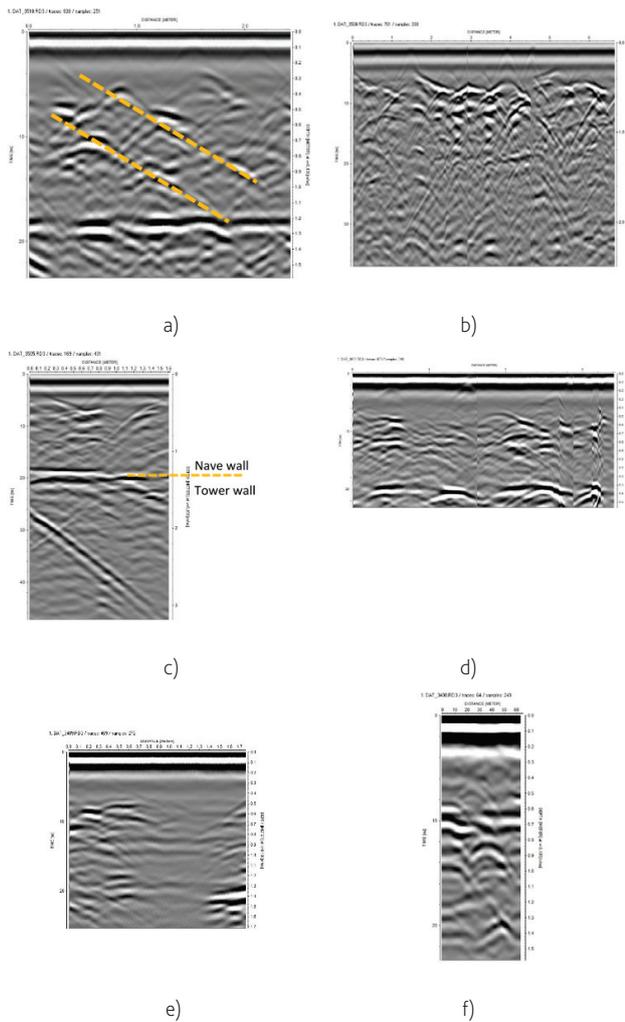
Figure 7 Radargrams at: a) GPR_1 northern wall choir level; b) GPR_2 western façade wall choir level; c) GPR_3 southern nave-tower wall interface choir level; d) GPR_4 southern wall; e) GPR_5 northern wall; f) GPR_5 beginning of the vault

Ground-penetrating radar was utilized in order to understand the inner constitution of the walls, identify any presence of damage and measure the thickness of the walls and the vault. The measurements were carried out with an 800 MHz antenna and the locations are shown in Figure 5. The GPR_1 radargram (Figure 7a) shows an internal view of the crack in that part of the wall. Patterns of hyperbolas show a specific trend rather than being random as

they would be on a normal wall and this explains the cracks as the consequence of detachment. From the GPR_2 radargram (Figure 7b) one can observe a difference in amplitude from the rest of the wall that is at the inner layer and the external interior masonry, which indicates a thicker separation between the layers and thus explaining the out-of-plane deformation perceived. On the southern wall in the choir level (GPR_3) a clear separation between the nave wall and the tower wall can be seen from the radargram in Figure 7c.

The radargrams for the walls (GPR_4 and GPR_5) show that the walls are composed of three-leaf walls, the inner layer is very regular and they contain a large number of interlocking stones (Figure 7d and Figure 7e). Lastly, from the measurement at the starting of the vault (GPR_5), it is found out that the thickness at its start is around 50 cm, which can be seen from Figure 7f.

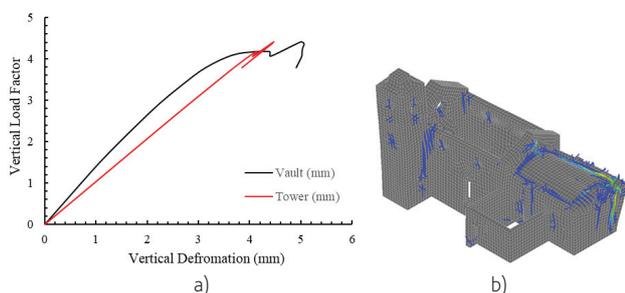
Figure 12 Results of pushdown analysis: a) capacity curve; b) crack distribution

In order to observe the present vertical load-bearing capacity of the structure, and derive the vertical load safety factor, a nonlinear pushdown analysis was performed. In this analysis, gravity forces were applied in increasing steps and analysis was deemed to be completed when major damage at the junction of wall and vault was observed. The total weight of the structure for the gravity loading was calculated as 2224 tons. Figure 12a shows the vertical load factor normalized concerning the total deadweight of the structure plotted against the vertical displacement at the center of the vault and tower top. Figure 12b shows the crack distribution observed for this analysis at peak load (load factor of 3.79).

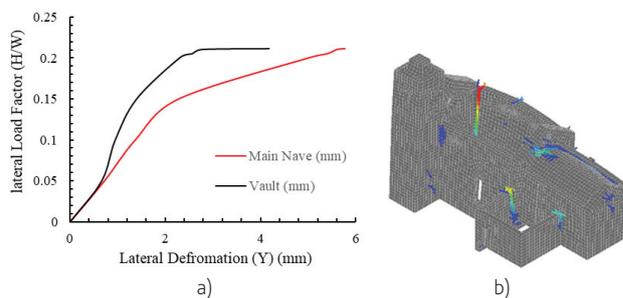
Figure 13 Pushover analysis (east-west direction): a) capacity curve; b) crack distribution

forces proportional to the mass. For the pushover analysis, gravity forces were initially applied, and a horizontal acceleration was imposed with appropriate load steps. The analysis was performed with the modified Newton-Raphson method. This was done to solve the non-linear equilibrium equations and find convergence based on energy balance. After performing the pushover analysis, displacement vs load factor was computed for the extreme points of the structure. From the lateral pushover in the east-west direction, the lateral capacity was found to be 0.15 g (Figure 13a) and damage at the peak load (0.21 g) in terms of crack distribution is shown in Figure 13b.

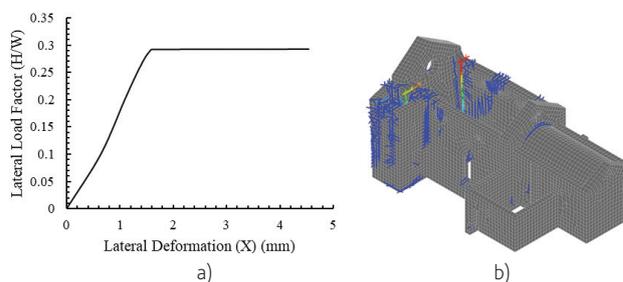
Figure 14 Pushover analysis (north-south direction): a) capacity curve; b) crack distribution

For the pushover analysis in the north-south direction, several cases of the Church's geometry were considered: without the tower, with the full tower, and with the tower at the same height as the main wall of the Church. This was done because the tower was not always have been a part of the main church and it was important to know the effect of the tower in different periods of its construction. The case with the tower at the same height as the main wall is presented for this particular case, a lateral capacity of 0.25 g was defined (Figure 14a), and at that stage, the crack distribution at the main nave is shown in Figure 14b.

From the pushover analyses at both the direction, it was observed that for the ground acceleration of 0.08 g, no major damage was observed except for minor cracking at the wall junctions. Moreover, these analyses were performed assuming conservative values of material properties that also contribute as a safety factor in these analyses. Apart from the localized injection of the walls aiming for its consolidation, no major structural repair works are suggested to a church standing for more than 800 years. Instead, a health monitoring system seems to be mandatory to follow the evolution of the major structural cracks.
