Assessment of seismic vulnerability of non-seismically designed unreinforced masonry buildings through shake table testing

CORREIA, A.A. [*et al.*] – Assessment of seismic vulnerability of nonseismically designed unreinforced masonry buildings through shake table testing. **Revista Portuguesa de Engenharia de Estruturas**. Ed. LNEC. Série III. n.º 12. ISSN 2183-8488. (março 2020) 89-98.

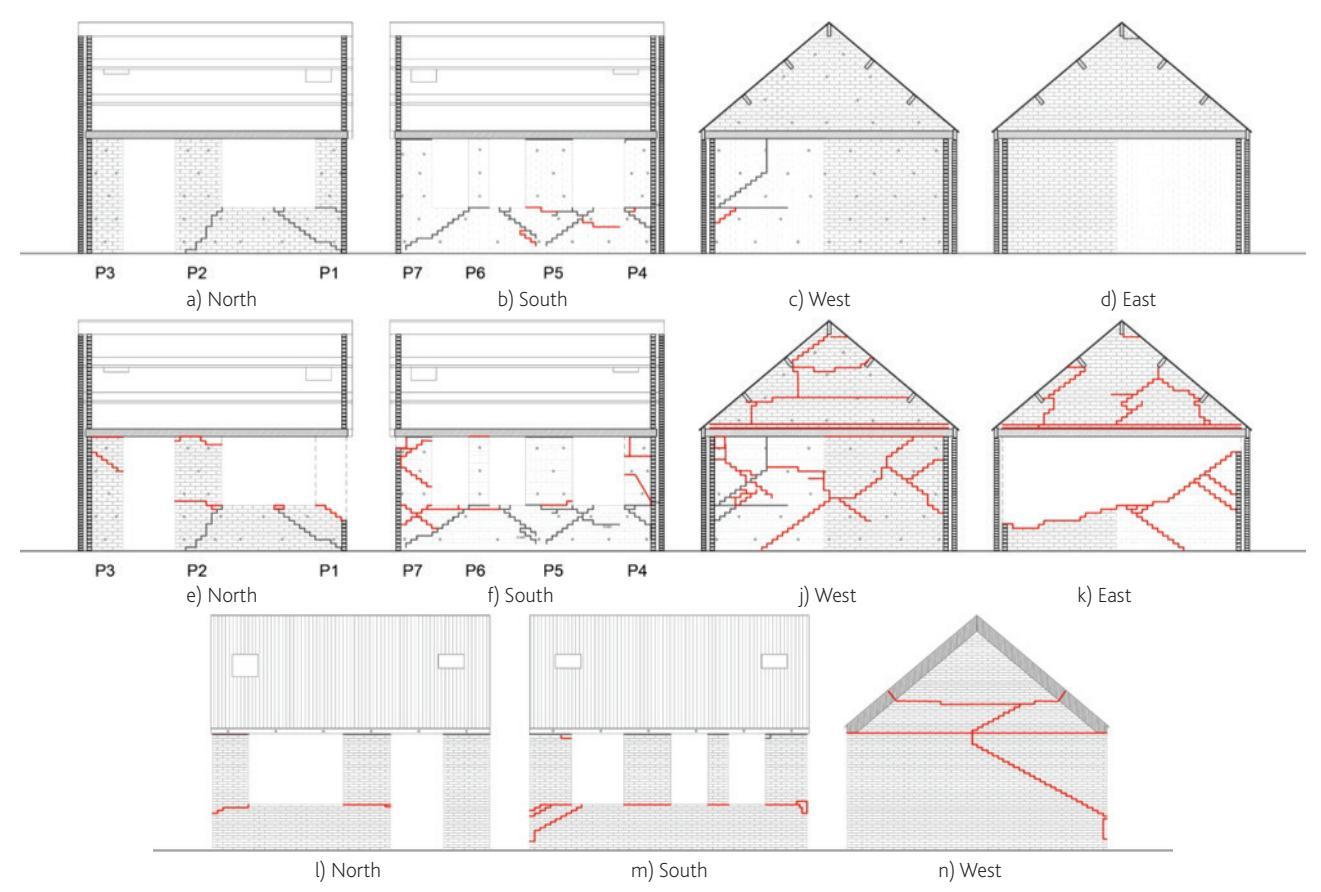
The FEQ2-150% test (H-PTA = 0.38 g) caused the development of new cracks and the elongation and widening of the pre-existing ones; a 1-mm-wide stepped diagonal crack appeared on the spandrel between piers 1 and 2 of the North CS wall. A further worsening of the existing crack pattern has been noticed at the end of test FEQ2-200% (H-PTA = 0.39 g); new horizontal cracks with negligible thickness have been observed in the plaster of pier 5 and spandrel between piers 4 and 5 of the South CS wall. Despite a clear rocking response of the gable walls, evident from the displacement histories recorded by the displacement transducers, no visible cracks were detected on them at the end of the tests. Moreover, the clay veneer walls did not suffer any significant visible damage up to test FEQ2-200%.

The (partial) collapse of the specimen prototype was attained during test FEQ2-300% (H-PTA = 0.63 g), exhibiting a rather fragile behavior. The pronounced rocking mechanism developed by the slender longitudinal piers and the vertical input motion on the prototype led to an uplift of the RC slab, causing a loss of restraint at the top of the East CS transverse wall, which failed out-of-plane. In addition to this local failure mode, a global severe damage in all longitudinal piers, associated with expulsion of materials, was observed. Severe damage occurred also in the West CS transverse wall due to the interaction between the displacement drift imposed by the floor and the out-of-plane actions induced by the wall's inertial forces and the outer veneer wall (*e.g.* pushing and pulling the wall by means of the steel ties). Cracks have been observed on both East and West CS gable walls, in particular in the regions close to the L-shaped steel anchors.

Regarding the performance of the outer veneer wall, no significant damage has been observed up to test FEQ-300%. Large relative displacements between the two leaves were measured (similarly to CAV-TH), even at earlier stages of testing. During the test where the specimen reached a partial collapse, horizontal cracks have been surveyed at the base of all longitudinal piers, a clear sign of rocking/ sliding behavior. The crack pattern surveyed on the West wall shows both the rocking mechanism of the system gable walls and roof and the triggering of a global pull-out/push-in of the veneer wall which is not directly connected to the slab.

Figure 7 Crack pattern on the CAV-TH-UP specimen after: (a-d) test FEQ2-200%, inner walls; (e-k) test FEQ2-300%, inner walls; (l-n) test FEQ2-300%, veneers. Cracks marked in black were pre-existing. Lightly shaded areas on the inner wall sketches identify plastered areas

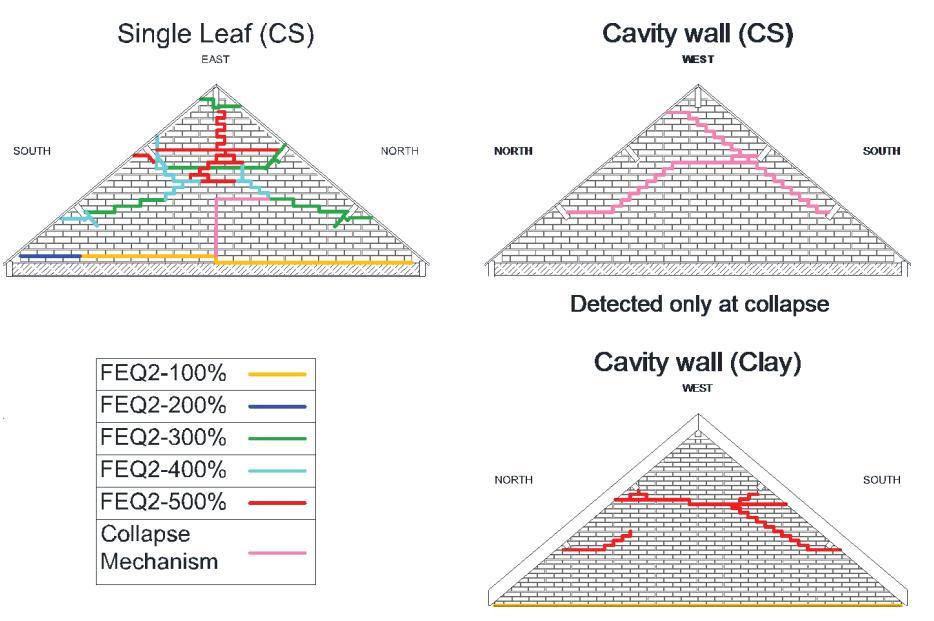
There was a crack opening at the base the CS East wall during test FEQ2-100%, with a permanent crack width of around 0.1 mm, due to a clear rocking response in that wall. Despite no crack being visible on the inner CS West wall, a coupled rocking response was measured between the two leaves and a crack was observed at the outer clay wall. Test FEQ2-150% caused no new damage on the structure, while FEQ2-200% has only extended already existing cracks. Nevertheless, a new significant reduction of the fundamental frequency of the roof specimen was observed after FEQ2-200%, similar to the reduction observed after FEQ2-100%.

During test FEQ2-300%, several new sub-horizontal cracks formed on the East gable wall with their origin at the connections between the CS wall and the roof beams. No new cracks were identified on the West wall for this test, nor for the following one: FEQ2-400%. On the other hand, the latter test induced an enlargement of the

Figure 9 Evolution of the crack pattern in the gable walls of the CAV-TH-RF specimen

Afterwards, test stage FEQ2-500% generated a set of cracks on the outer clay leaf of the West wall, very similar to the one produced on the East wall during FEQ2-300%. On the East wall, the main crack opening was a vertical one from the ridge beam downwards, largely contributing to the formation of the collapse mechanism mobilized on the subsequent test, FEQ2-600%. During this last test, another vertical crack formed on the East gable wall, now originating from the bottom of the wall and completing its collapse mechanism. Only then important cracks on the inner leaf CS West wall were detected. The (partial) collapse of the specimen prototype was thus attained during test FEQ2-600%. Figure 10 illustrates the final damaged state of the model and the unrecovered permanent deformations. It is especially interesting to note that, even at this post-collapse state, the West wall and the timber roof system still retained a full load-carrying capacity for gravity loads.

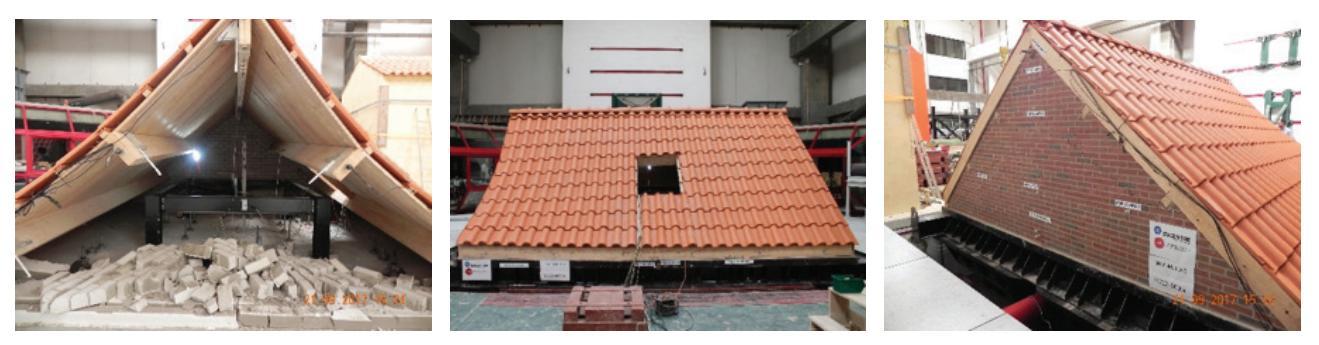
Figure 10 Damaged specimen at the end of test FEQ2-600%

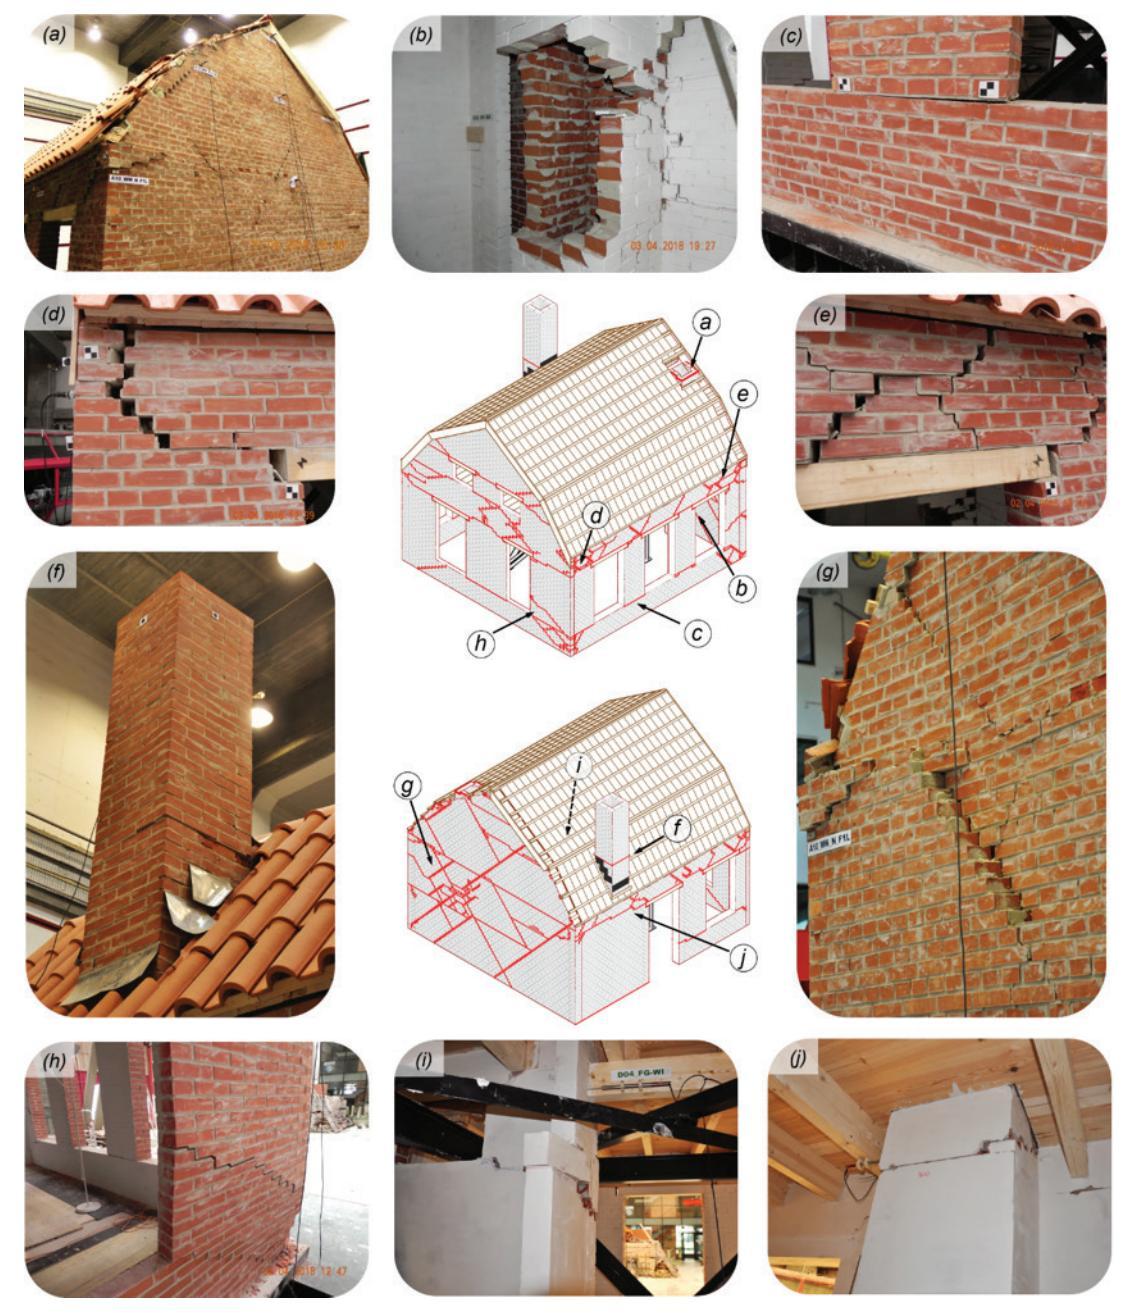
shaking under SC2-200% (PGA = 0.29 g), and was considered at near-collapse state after test SC2-400% (PGA = 0.68 g) when the West chimney collapsed, and the rest of the structure underwent substantial degradation. During test SC2-500% (PGA = 1.0 g), debris from the West chimney fell in the interior of the building and

Figure 12 Observed damage after test SC2-500%: a) collapse of West façade chimney; b) collapse of the West chimney in the interior of the building; c) flexural crack at the base of a North pier; d) cracks at the top of the North wall due to out-of-plane mechanism of the East façade; e) large permanent openings on the North spandrels; f) cracking of the South chimney; g) mortar-joint sliding on the West façade; h) near-collapse state of the East façade; i) damage in the interior wall; j) horizontal crack at the base of the South chimney stack

portions of the East and North façades displaced as rigid bodies by sliding. A considerable percentage of the walls had lost their loadbearing capacity, and the structure was barely in equilibrium. The building would not survive further shaking; therefore, tests were stopped to prevent collateral damage to the instrumentation and the shake table.
