Assessment of strengthening solutions for the out-of-plane collapse of masonry infills through textile reinforced mortars

RISI, M. T. [et al.] – Assessment of strengthening solutions for the out-of-plane collapse of masonry infills through textile reinforced mortars. **Revista Portuguesa de Engenharia de Estruturas**. Ed. LNEC. Série III. n.º 11. ISSN 2183-8488. (novembro 2019) 35-42.

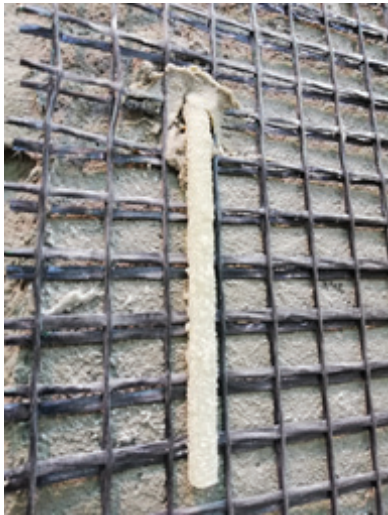
Figure 3 Specimen R2-OOP: Detail of the L-shape connector

The strengthening solution selected for specimen R2-OOP was similar to the one adopted for specimen R1-OOP. The only difference among them was related to the anchorage of the net to the frame. In this case, L-shape connectors were used to fix the net to the RC frame (Figure 3). The application procedure adopted to apply this connectors was: 1) application of the first layer of plaster with thickness equal to 1 cm; 2) application of the net; 3) drilling a hole with ϕ 6 mm diameter and 10 cm length for each connector; 4) full filling of the hole with epoxy resin (provided by the manufacturer); 5) application of the L-shape connector; and 6) application of the second layer of 1 cm plaster. The net and the plaster were the same used in the specimen R1-OOP.

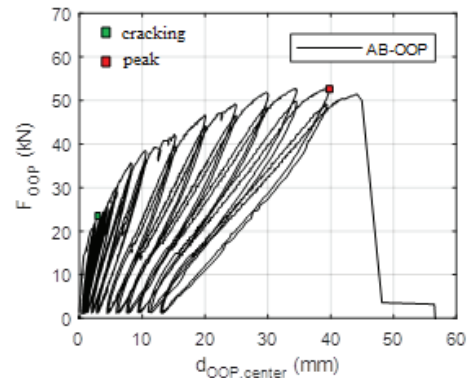
Figure 5 Test AB-OOP: F_{OOP} - d_{OOP} response

Figure 5 shows the semi-cyclic OOP force-displacement response for the as-built specimen AB-OOP. First, note that the OOP displacement used in this plot (and in the similar ones in the following analyses) is the displacement monitored by the displacement transducer located in the geometrical centre of the panel (see LVDT 64 in Figure 4c). The initial (secant) stiffness of this response – calculated as the ratio between F_{OOP} and $d_{OOP,center}$ at the first peak related to the first applied displacement level – is equal to $k_{OOP,sec,in} = 8.89$ kN/mm. By increasing the applied OOP displacement, a first visible (macro-) cracking was observed on the panel for an applied OOP displacement in the centre equal to 2.5 mm, at $F_{OOP,cr} = 21.81$ kN (see Figure 5). At this stage, a horizontal crack along a mortar bed joint occurred in the middle of the panel, as shown in Figure 6a. The secant stiffness related to this first cracking is thus slightly lower than the initial one, and in particular equal to 8.72 kN/mm. Secant stiffness progressively reduced during the test, and progressively wider cracks appeared in the panel, drawing on it a quite clear “pavilion” shape until the peak load is reached

(Figure 6b). The “pavilion” deformed shape highlights the existence of a double-arch (horizontal and vertical) resisting mechanism, as expected for an infill panel connected with the surrounding frame along four-edges [3]. The maximum OOP load corresponding to this stage was equal to $F_{OOP,max} = 52.68$ kN at $d_{OOP,center,max} = 39.55$ mm. The corresponding secant stiffness thus reduced to 1.33 kN/mm.

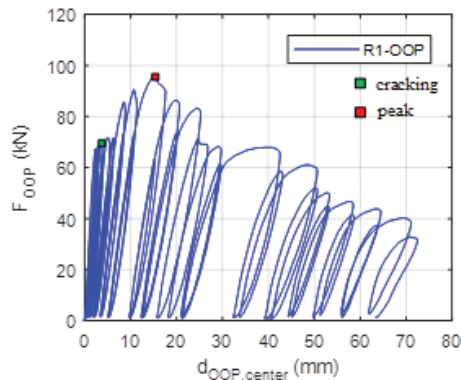
Figure 7 Test R1-OOP: F_{OOP} - d_{OOP} response

Figure 7 shows the OOP force-displacement response for the first retrofitted specimen (R1-OOP). For this test, the initial (secant) stiffness of the response – calculated as explained before – is equal to $k_{OOP,sec,in} = 29.15$ kN/mm, namely significantly higher (+228%) than the $k_{OOP,sec,in}$ related to the specimen AB-OOP. Such a difference is mainly ascribable to the presence of the plaster for the specimen R1-OOP. By increasing the applied OOP displacement, first visible (macro-) cracks were observed on the panel for an applied OOP displacement in the centre equal to 3.6 mm, at $F_{OOP,cr} = 70.47$ kN (see Figure 7). At this stage, hairline horizontal and vertical cracks appeared in the middle of the panel, as shown in Figure 8a. The secant stiffness related to this first cracking thus reduced to 19.58

kN/mm. Secant stiffness progressively reduced during the test, and progressively wider cracks appeared in the panel, with additional diagonal cracks in the bottom portion of the panel, until the peak load was reached (Figure 8b). The maximum OOP load corresponding to this stage was equal to $F_{OOP,max} = 95.95$ kN at $d_{OOP,centre,max} = 15.00$ mm. At peak load, a significant detachment from the top beam was observed.

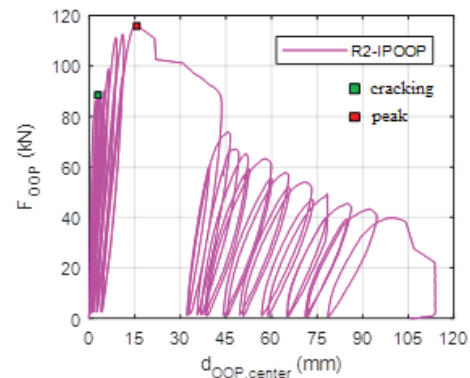
Figure 9 Test R2-OOP: F_{OOP} - d_{OOP} response

Figure 9 shows the OOP force-displacement response for the retrofitted specimen R2-OOP and the corresponding deformed shape at the peak load, as for the previous tests. For this test, the initial secant stiffness – calculated as explained before – is equal to $k_{OOP,sec,in} = 34.85$ kN/mm, namely slightly higher (about +20%) than the $k_{OOP,sec,in}$ related to specimen R1-OOP, likely due to the stronger degree of connection between the retrofitting plaster on the panel and the RC frame. For increasing applied OOP displacement, a first visible (macro-) cracking was observed on the panel, at $F_{OOP,cr} = 89.73$ kN and a corresponding displacement $d_{OOP,center}$ equal to about 3 mm (see Figure 10a). At this stage, a hairline horizontal
