# Residual load carrying capacity of ASR damaged reinforced concrete beam after 12 years exposure

Susumu Inoue

INOUE, S. – Residual load carrying capacity of ASR damaged reinforced concrete beam after 12 years exposure. **Revista Portuguesa de Engenharia de Estruturas**. Ed. LNEC. Série III. n.º 15. ISSN 2183-8488. (março 2021) 45-54.

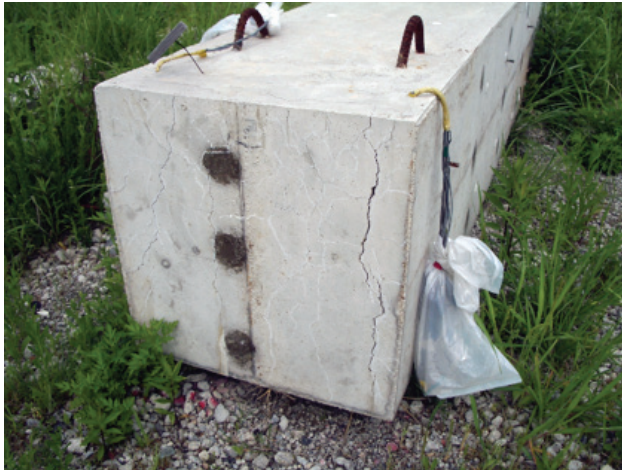
**Figure 3** Exposed specimen (at the age of 1.5 years)

This beam was exposed to outside natural environment but off the ground for 4495 days (more than 12 years) after casting of concrete as shown in Figure 3. During the exposure, it was simply supported and subjected to the stress caused by its own weight. During the last 5 years of exposure, the temperature range was  $-4.8$  to  $39.6$  degree centigrade and the average was  $16.4$  degree centigrade, while the average relative humidity was about  $72.5\%$ . During the exposure, changes in the vertical, horizontal and longitudinal strain of the concrete surface and ultrasonic pulse velocity were measured in addition to the observation of crack propagation.

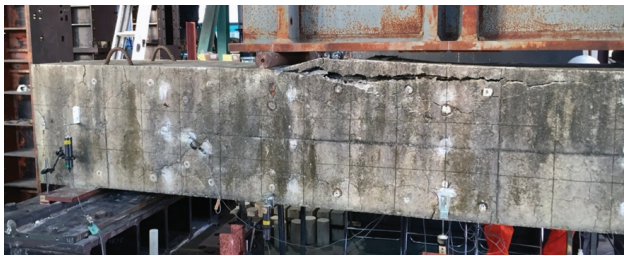
**Figure 8** The appearance of the beam after the loading test

Figure 8 shows the appearance of the beam after the loading test. In Table 3 are listed the measured maximum load and so on together with the calculated flexural and shear capacity according to the JSCE Standard Specifications for Concrete Structures [7], in which the mechanical properties of concrete at 4495 days were used and the material factors were set to be 1.0.

The measured maximum load well exceeded the calculated flexural capacity. However, the cover concrete in the compression zone of section peeled off in layers along with the existing expansive cracks at the ultimate state as seen in Figure 8. From these results, the design ultimate capacity of ASR damaged members might be guaranteed as long as no rupture occurs in tensile and shear reinforcements, although the final failure mode would be affected by the condition of existing cracks.

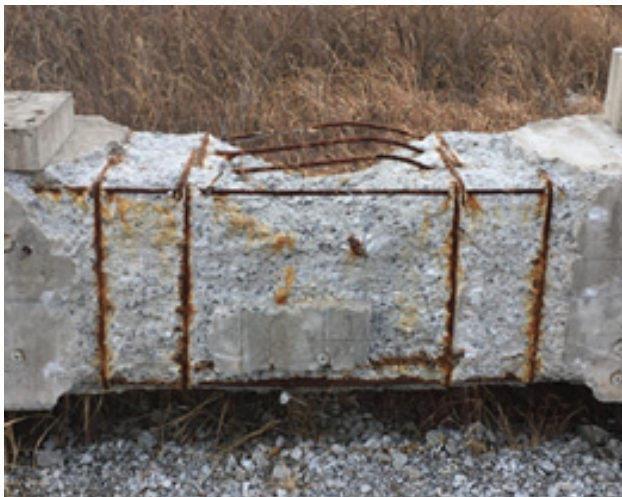
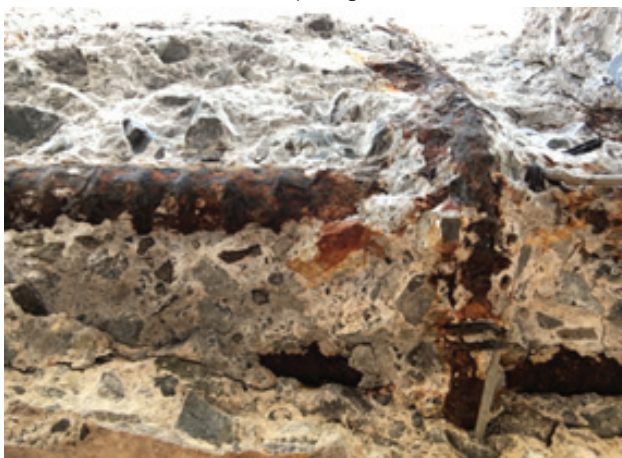
**Figure 12** Condition of longitudinal bars and stirrups

After the loading test, cover concrete in the mid-span region was tipped away and the condition of longitudinal bars and stirrups was observed. Figure 12 shows some profiles of the observed conditions. As seen in Figure 12, longitudinal bars as well as stirrups corroded severely during the exposure due to the influence of NaCl which was added to obtain the prescribed total alkali contents. However, rupture of stirrups was not observed irrespective of the bending radius at the corners. One of this reason was that the shape of lugs and ribs of the used reinforcing bars was different from those of the ones used in the practical structures constructed more than several decades ago in which the rupture of them was detected. As shown in Table 3, the measured maximum flexural capacity exceeded well the design value and the final failure mode was flexure although shear was predicted. From these results, ASR expansion and reinforcement corrosion in the tested beam did not significantly affect the load carrying capacity.

Mid-span region

Bent corner of a stirrups

Although the rupture of stirrups was expected during the long-time exposure, no rupture occurred practically in spite of large expansion and relatively severe corrosion. Thus, the residual load carrying capacity of ASR damaged members might be guaranteed as long as the rupture of stirrups as well as tensile reinforcement did not occur.
