Seismic strengthening applied to heritage: an experimental study on rubble stone masonry walls

Madalena Ponte

PONTE, M. [et al.] – Seismic strengthening applied to heritage: an experimental study on rubble stone masonry walls. **Revista Portuguesa de Engenharia de Estruturas**. Ed. LNEC. Série III. n.º 17. ISSN 2183-8488. (novembro 2021) 23-30.

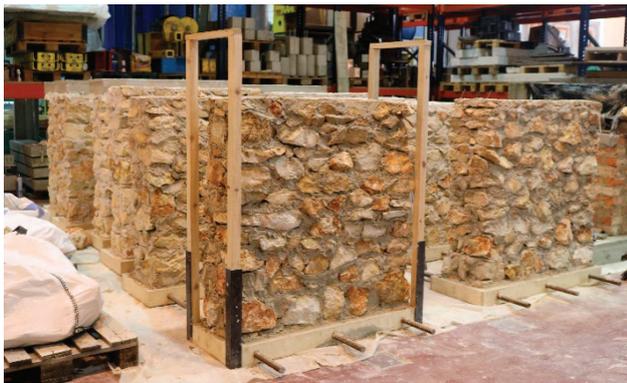
Figure 1 Construction of the masonry specimens at LERM, IST

Six $120 \times 120 \times 40$ cm³ specimens of rubble stone walls representative of ancient Portuguese monuments were built in the Structures and Strength of Materials laboratory (LERM) of Instituto Superior Técnico Structures (Figure 1) to assess their behaviour under quasi-static cyclic shear tests. After the walls were dry (minimum 28 days), strengthening solutions with Glass- or Carbon-FRP mesh and lime-based binder (GFRCM/CFRCM system) were applied. Each solution was applied to two specimens, being in total: 2 walls unreinforced (URM 1 and URM 2), 2 walls with GFRP system (G 1 and G 2), and 2 walls with CFRP system (C 1 and C 2). The FRCM system was applied only on one side of the specimens, as is the case of many historic buildings due to the frequent presence of mural paintings on the walls.

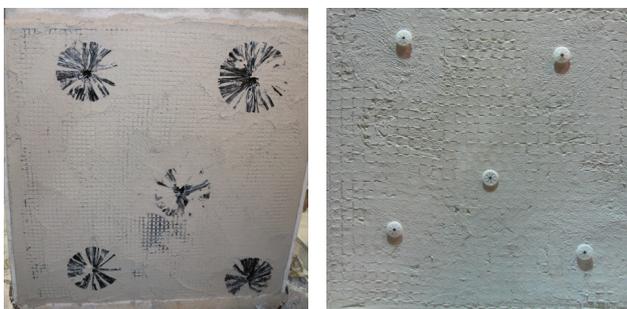
Figure 2 Application of carbon- (left) and glass- (right) FRCM systems on specimens

The mortar used to help fixing the FRP meshes to the substrate is suitable for the technique and based on a natural hydraulic lime mortar – REABILITA CAL FORCE (compression strength $> 14 \text{ N/mm}^2$, following EN 998-1 [11]). Regarding the application of the FRCM systems, the glass FRCM system (GFRCM) applied is marketed by SECIL group, while the carbon FRCM system (CFRCM) is marketed by the company S&P Clever Reinforcement Ibéria. Both meshes are bi-directional. The glass mesh used is named REABILITA REDE AR 160, with openings of $40 \times 40 \text{ mm}$ and a weight of 160 g/m^2 . The connectors used in the GFRCM system are applied by pressure and a second layer of a grid with smaller openings was added in a reduced area around the connectors (approximately 20 cm in each direction) to help distribute concentrated stresses (Figure 2, on the right).

The carbon mesh used is named S&P ARMO-mesh 500/500, with openings of $17 \times 17 \text{ mm}$ and a weight of 374 g/m^2 . The connectors used in this system are also made of carbon fibres with a length to distribute the concentrated stresses of approximately 20 cm (Figure 2, on the left).

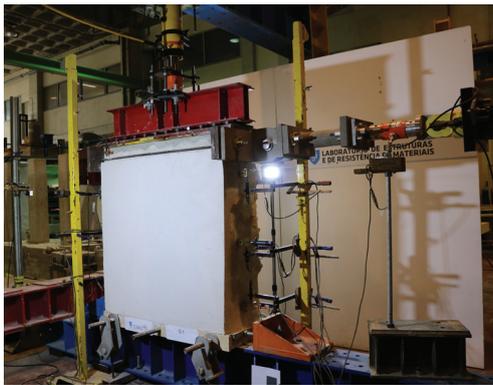
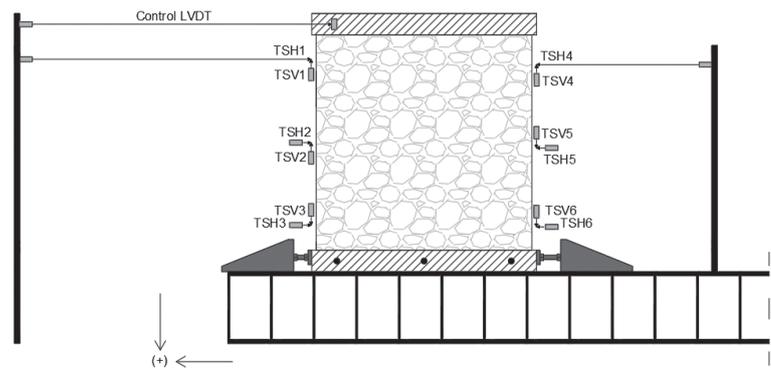
Figure 3 Images of the quasi-static cyclic tests set-up

Quasi-static cyclic tests were performed on all specimens according to [14]. Vertical stress of 0.3 MPa was applied to the specimens based on the actual state of stresses of load-bearing walls in old Lisbon masonry buildings [1], and on the state of stress at the bottom of walls of the chapel of the National Palace of Sintra [15]. Thus, the specimens were first subjected to a vertical pre-compression load, that was kept constant, as much as possible, during the quasi-static cyclic test. The walls were tested with boundary conditions as cantilever systems, fixed at the concrete base and allowing displacements and rotations at the top of the specimen. After the vertical load was applied, the horizontal load was transmitted by a mechanical actuator at the top of the wall through a system of steel plates appropriately connected with steel bars. The set-up is presented in Figure 3.

On each lateral side of the wall, horizontal and vertical LVDT's were placed as close as possible to the top, mid-height, and bottom of the wall, while taking into consideration that the holes to fix the connectors' supports need to be drilled in the stone.

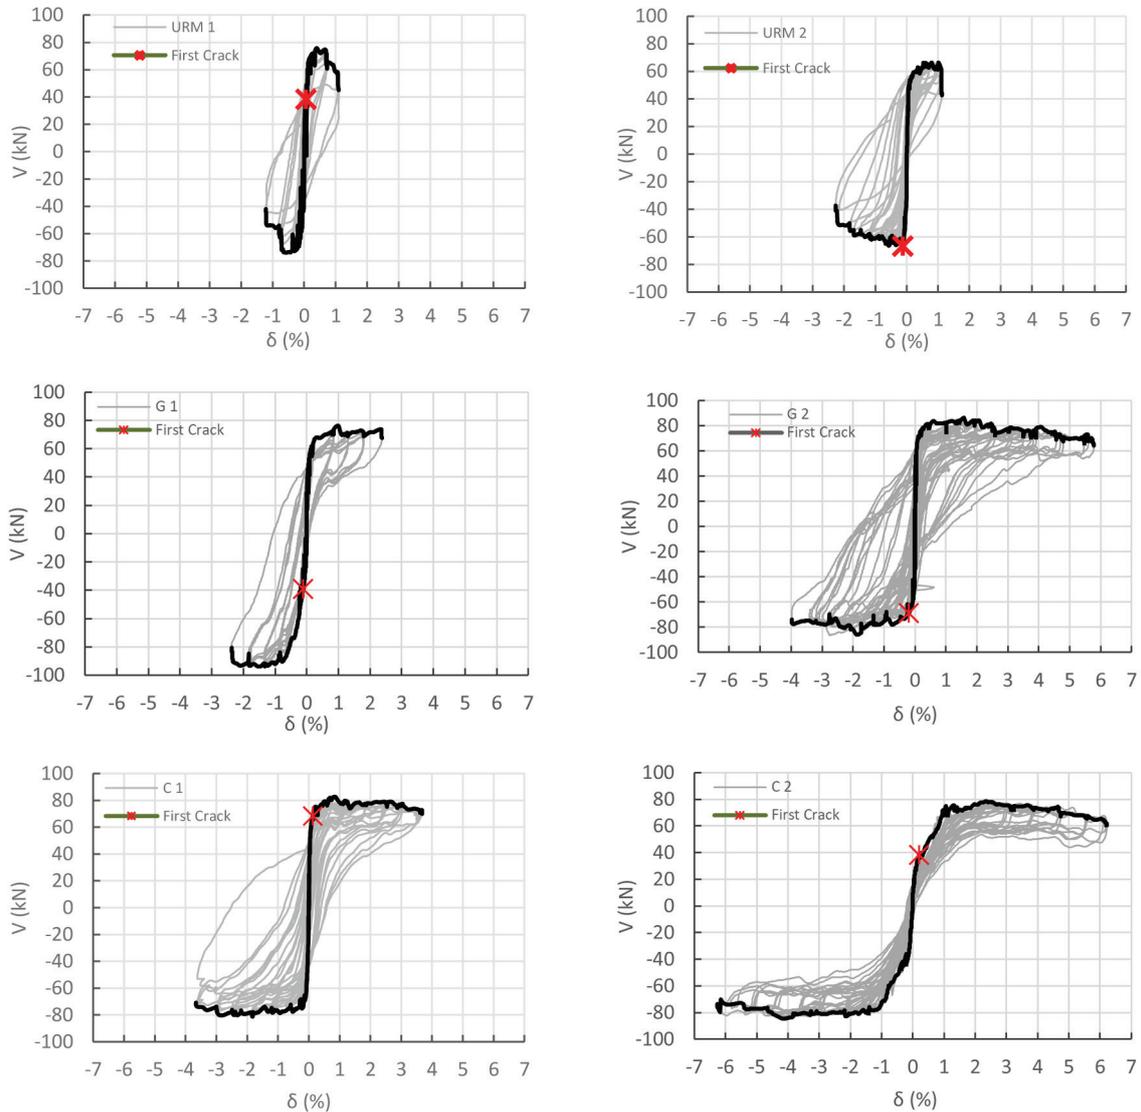
Figure 4 Force-displacement hysteretic and envelope curves

Figure 4 presents the horizontal force-displacement hysteretic curves. The shear force V is the horizontal force exercised by the horizontal actuator on the concrete beam at the top of the wall. δ is the in-plane horizontal drift calculated by dividing the difference of the top horizontal displacement and the displacement at the bottom of the wall, by the total height (from the base until the point of the load application). The envelope curves were defined by considering the value of the force at the first time a displacement is attained in the cyclic curves. Also, in Figure 5 are presented the failure modes of each specimen at the end of the tests. Failure henceforth was defined as the point when a reduction of 20% of the peak load was detected, or when the damage level was so high that the integrity of the wall was at risk.

For both unreinforced walls (URM 1 and URM 2), there is a clear force decay after reaching the peak load. At that stage, the walls were completely damaged with clear diagonal shear cracks at both sides of specimens and the detachment of parts of the walls was on the verge of occurring. The cracks developed along the mortar bed joints.

In the case of the strengthened walls, the weakest part became the connection between the concrete foundation and the wall. Therefore, the first damage to appear for the strengthened walls was always its detachment from the concrete base, which is marked in the envelope curves as the first visible crack. Even though this occurred, it was possible to observe clear improvements in the behaviour of the strengthened walls regarding the unstrengthened ones. Following the detachment of the strengthened walls from

Lastly, wall C 2 behaves as a rigid body with a typical rocking behaviour. The wall is substantially undamaged with only a few small horizontal cracks at the base corners when a decrease of 20% of the peak load is reached. Furthermore, there is almost no dissipation of energy in the hysteresis diagram.

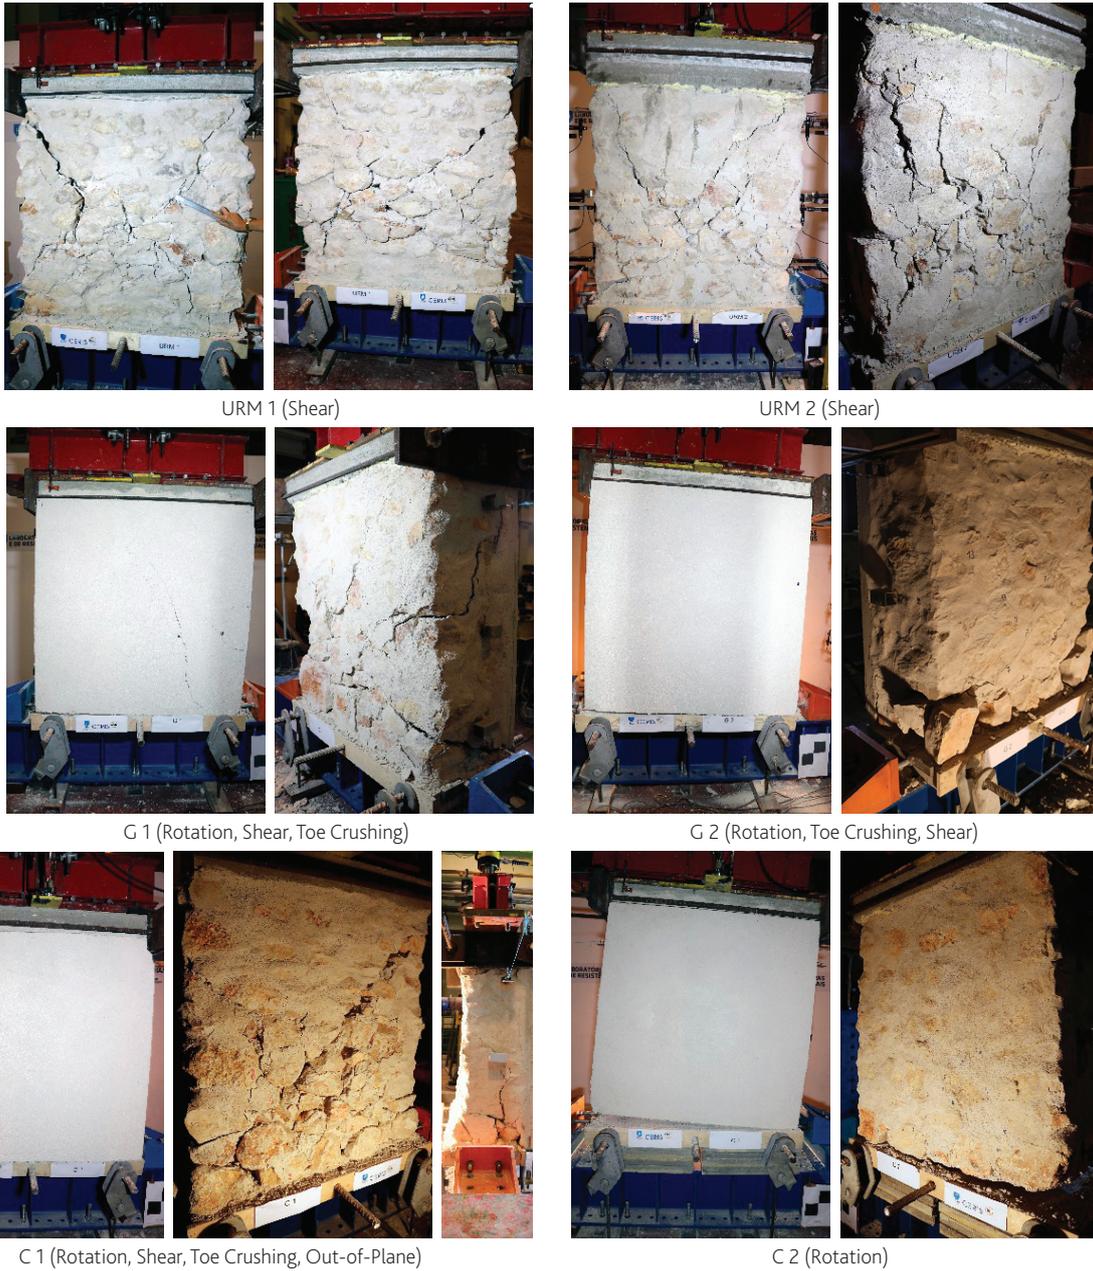
Figure 5 Failure modes at the end of the tests

For wall G 1, during the rocking behaviour, diagonal shear cracks started to appear, going through the wall in-depth, immediately followed by the detachment of the lower cornerstones. Only a crack is visible on the side with the strengthening solution, while the majority is located on the facade without strengthening and on the sides. It is also worth mentioning that this is the only wall where damage is visible on the side with strengthening. The early reduction of stiffness on the negative side (pull) of the envelope curve is due to the early detachment of the wall from the concrete base on the left side of the specimen. Even though the extensive damages of G 1, indicating collapse, the specimen did not present strength's decay. The test was interrupted for a drift of about 2.4% due to a possible fall of parts of the wall that were severely damaged.

Wall G 2 presents less damage than G 1, one diagonal shear crack (with a small opening) from corner to corner is visible in the backside of the wall (unstrengthened side). The damage is mostly concentrated in the corners, where toe crushing occurs, and the lower stones got detached. In this wall, it was verified a small decrease of strength and the test was interrupted when 80% of the peak load was attained, exhibiting a higher drift capacity than G 1.

Wall C 1 presents clear damage with several wide diagonal shear cracks in the unstrengthened side of the wall. The test was interrupted before reaching the 20% decay of strength, due to the separation of the two leaves of stone of the wall, causing instability on the wall with a possible out-of-plane collapse.

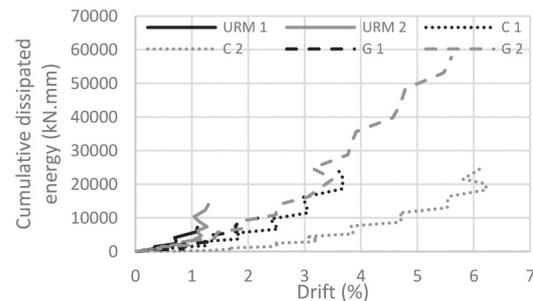
Figure 6 Cumulative dissipative energy of each specimen as a function of lateral drift

The cumulative dissipated hysteretic energy was calculated for each cycle and compared with the corresponding maximum drift, as presented in Figure 6. It is possible to observe that the

unstrengthened walls present higher dissipated energy when compared with the strengthened walls. This was expected due to the shear failure of walls URM 1 and URM 2. On the other side, the dissipated energy for the strengthened walls presents a very similar trend along with the increase of the lateral drift, except for wall C 2 that presents a rigid body behaviour with no damage, as already commented while analysing the hysteretic curves.
