Assessment of seismic vulnerability of non-seismically designed unreinforced masonry buildings through shake table testing

CORREIA, A.A. [*et al.*] – Assessment of seismic vulnerability of nonseismically designed unreinforced masonry buildings through shake table testing. **Revista Portuguesa de Engenharia de Estruturas**. Ed. LNEC. Série III. n.º 12. ISSN 2183-8488. (março 2020) 89-98.

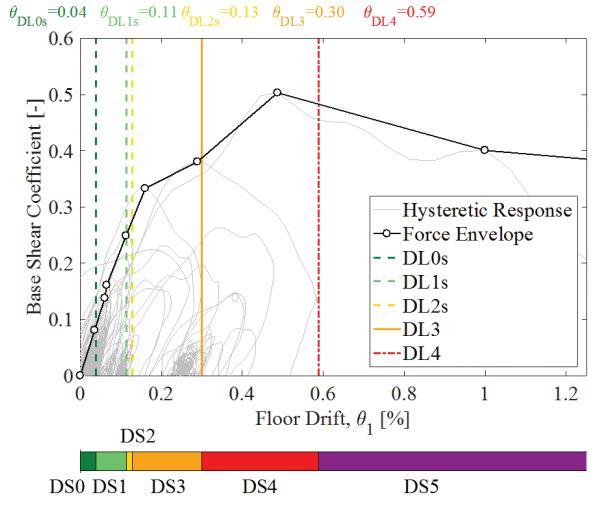
Figure 8 Base shear backbone curve and damage state limits on the CAV-TH-UP specimen

Figure 8 plots the backbone curve in terms of base-shear coefficient (BSC) and global drift ratio for the specimen. The global drift ratio is the upper floor displacement divided by the corresponding height above the shake table. The BSC was computed as the sum of the products of each accelerometer's readings times its tributary mass, lumped at the accelerometer location, divided by the total weight of the specimen. The (partial) collapse of CAV-TH-UP was reached at a global drift of more than 4%, under a PGA of 0.48 g, with the other damage states identified in Figure 8.

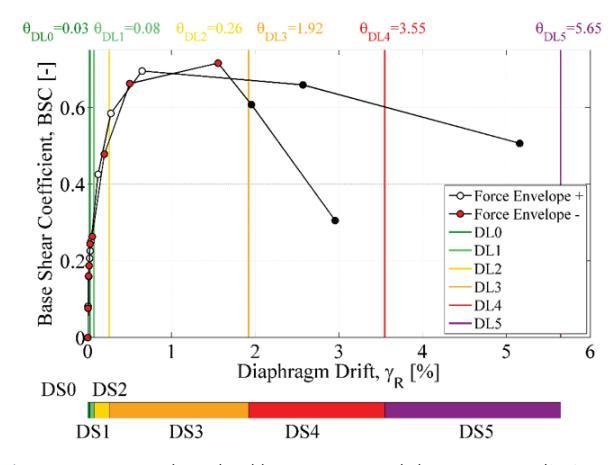
Figure 11 Base shear backbone curve and damage state limits on the CAV-TH-RF specimen

The evolution of the specimen's backbone response is shown in Figure 11, in terms of BSC *versus* roof diaphragm drift, γ_{R} . The identification of global quantitative thresholds that adequately

describe the overall structural damage state of the building is also attempted in Figure 11.

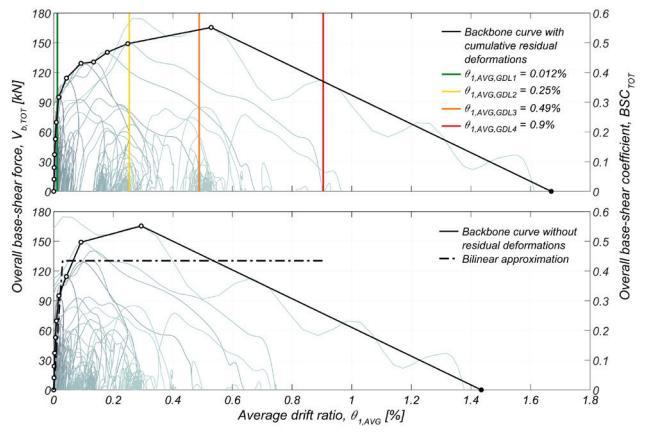
Figure 13 Base shear backbone curve and damage state limits on the CLAY-DH specimen

Figure 12 illustrates the damage appeared on the building by the end of the testing sequence. A detailed description of the damage evolution can be found in [8]. Among other aspects, the tests allowed defining damage limit states, from first structural damage up to near-collapse conditions, for the performance-based assessment of clay-URM buildings, as shown in Figure 13.
