# Structural behavior of Pracana dam 30 years after rehabilitation due to severe ISR-ASR damage

José Piteira Gomes  
Domingos Silva Matos  
António Lopes Batista  
José Ilídio Ferreira

GOMES, J. [et al.] – Structural behavior of Pracana dam 30 years after rehabilitation due to severe ISR-ASR damage. **Revista Portuguesa de Engenharia de Estruturas**. Ed. LNEC. Série III. n.º 16. ISSN 2183-8488. (março 2021) 85-94.

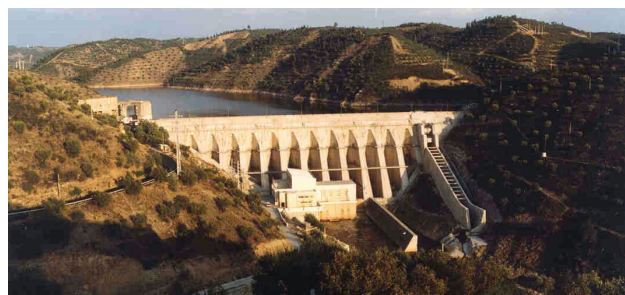
Figure 1 Downstream view of Pracana dam in 1992, after the rehabilitation works

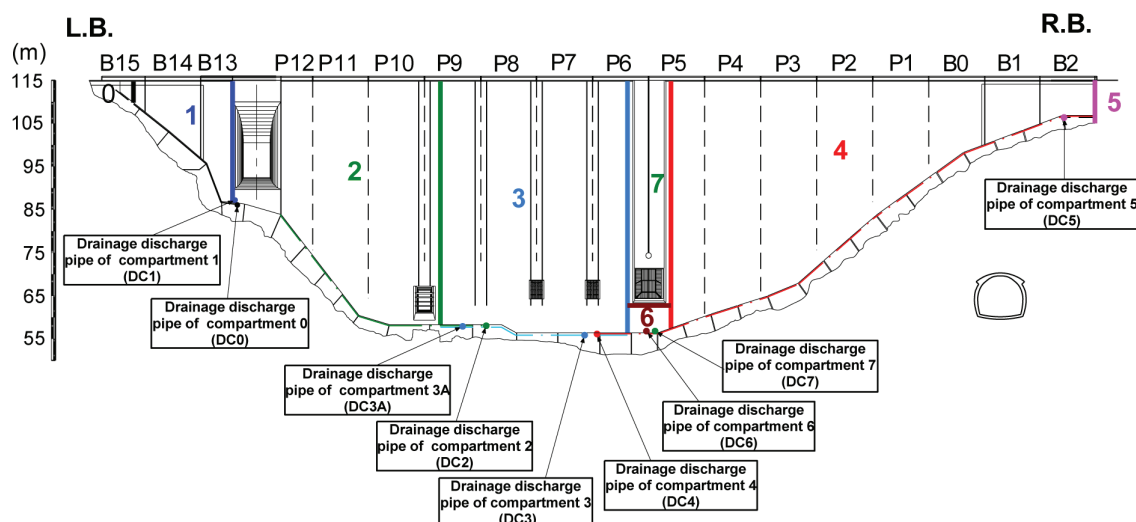
The drainage system, installed between the waterproofing system and the upstream concrete face of the dam, is divided into eight main independent compartments, as shown in Figure 10. The water collected in each compartment is conducted to drains located at the upstream face, immediately above the plinth surface, which are equipped with downstream outlets to enable the measurement of the respective discharges.

Figure 11 shows the discharges evolution in the different geomembrane drainage compartments. As can be seen, in the compartments 1 and 4, where several membrane ruptures have occurred, the discharges were higher. In compartment 1, where the most significant ruptures occurred in 2011, 2018 and very recently (December 2019), the discharges have reached maximum values of about 75 l/min. The discharges from compartment 4 had a first increase between 2000 and 2003, with maximum values of about 65 l/min, but since 2011 to 2016 the increase was higher, reaching a maximum value of 209 l/min in April 2016. In November 2016 there was a geomembrane repair intervention that drastically

**Figure 10** Drainage system of geomembrane from the eight independent compartments, with location of the drainage discharge pipes of each compartment

reduced those discharges. However, in 2019 new rips appear to have occurred.
