Structural analysis of the Barrô Romanesque Church

OLIVEIRA, D. [et al.] – Structural analysis of the Barrô Romanesque Church. **Revista Portuguesa de Engenharia de Estruturas**. Ed. LNEC. Série III. n.º 17. ISSN 2183-8488. (novembro 2021) 61-70.

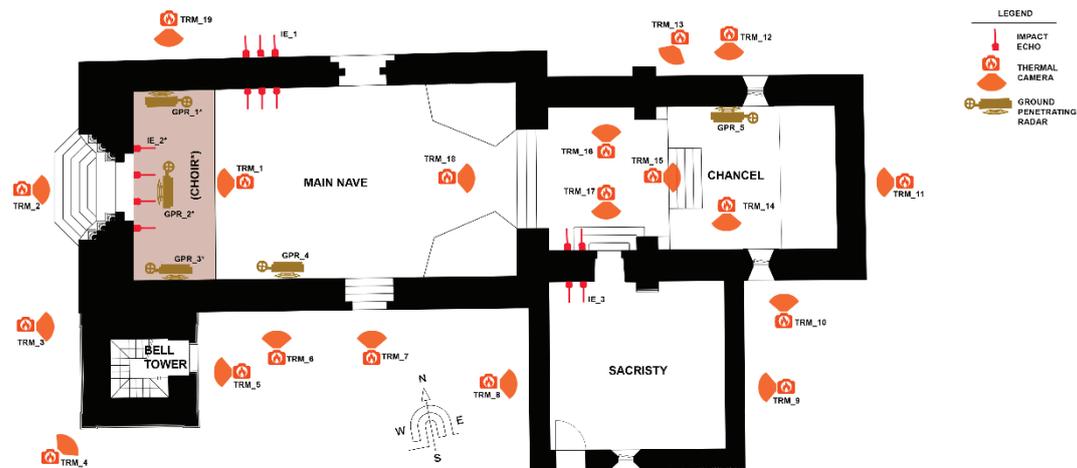
Figure 5 Non-destructive test locations (*for the tests in the Choir level)

From TRM_7, it can be observed that on the left side there is a clear separation of the arch above the door to the stone filling underneath, not clearly visible to the naked eye. Additionally, from TRM_11 another distinct separation between the sculpture stand and the rest of the wall can be seen. TRM_15 shows material differences between the altar and the stone vault, which has a clear

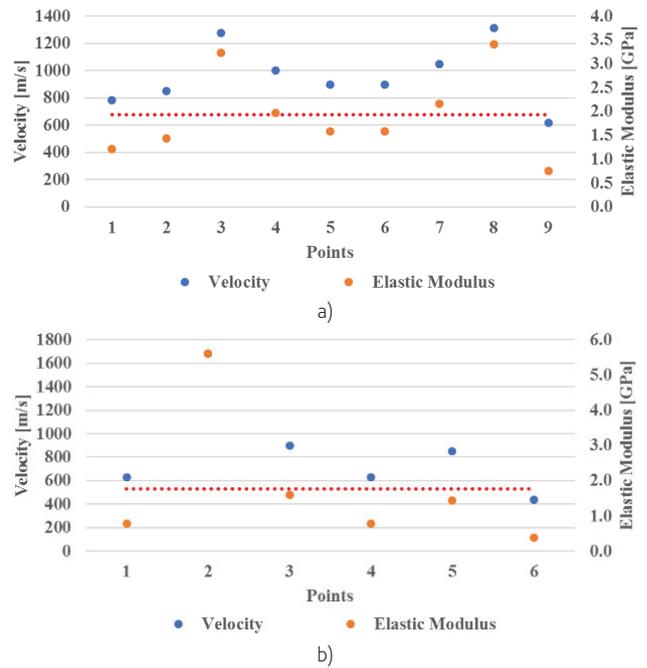
Figure 8 Correlation between velocity and the elastic modulus in: a) northern wall IE_1; b) southern wall IE_3

The elastic wave method impact-echo was performed in 3 locations as shown above in Figure 5, where IE_1 and IE_3 with the direct method and IE_2 with the indirect method. IE_1 was carried out in 9 points with a layout of 3 by 3 points each separated 50 cm from each other. The elastic modulus is correlated with the velocities utilizing the formulations for P and R waves and a Poisson's ratio of 0.2 and a common density for stones of about 2.2 ton/m³. Similarly, for the test IE_3, 6 points with a layout of 2 by 3 each separated by 50 cm from each other were tested. The correlation between the velocities and elastic modulus for tests IE_1 and IE_3 is shown in Figure 8. A mean elastic modulus value comes up to be around 2.0 GPa with slight deviations in some points of IE_1 and only one

point of deviation in IE_3, which may be due to the presence of interlocking stones.

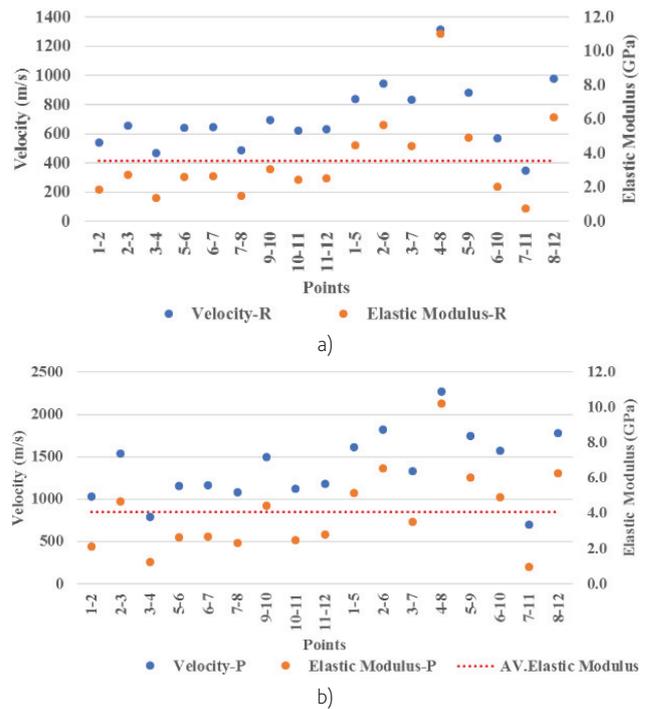
Figure 9 Correlation between velocity and the elastic modulus: a) R-waves; b) P-waves

In contrast, 12 points were measured in IE_2 (choir level) with a layout of 4 by 3 separated by 50 cm in the vertical direction and 100 cm in the horizontal direction (shown in Figure 9). The mean elastic modulus from the P-wave and R-wave measurements is around 4.0 GPa with a deviation at point 4-8.

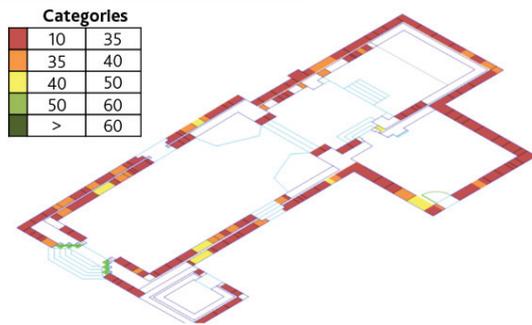
Figure 10 Results from the rebound hammer in the form of a table (left) and visual classification (right)

The rebound hammer test provides a superficial measurement of the hardness of materials. In the case of stone masonry with dry joints the rebound hammer gives only qualitative measurements of surface hardness as to be compared relatively between different locations in the church (outside “EXT” and inside “INT”). This comparison is done with the sole purpose of identifying the weaker spots of the masonry. The rebound values from this test are shown in the form of a table and visually classified represented by distinctive colors in Figure 10.

Min	Max	Avg	SD	CoV
Nave_INT	22	50	32.5	5.7	18%
Nave_EXT	10	50	31.1	7.8	25%
Chancel_INT	14	45	30.7	6.7	22%
Chancel_EXT	12	60	27.6	7.5	27%
Sacristy_EXT	12	52	28.4	8.1	28%
Tower_INT	15	41	28.4	6.8	24%
